# Aztech Environmental

## **RE: Sub-Slab Depressurization System (SSDS) – 2018 Annual Inspection**

The three (3) SSDSs installed at 510 Furnace Dock Road (the site) located in Cortlandt Manor, New York have been operational since their installation in December of 2011. Each of the three (3) individual systems is comprised of two (2) sub-slab vapor extraction points. All three (3) systems are equipped with Radonaway HS-2000 fan units. Each system is also equipped with a pressure indicating alarm which illuminates a light in the event that the vacuum inside of the system falls below 0.25 inches of water column. All plumbing was completed using three-inch Schedule 40 PVC pipe and solvent-welded fittings. The three (3) fans were mounted securely to the roof and all piping was installed on a pitch to allow any condensation to flow back into the ground beneath the building's slab.

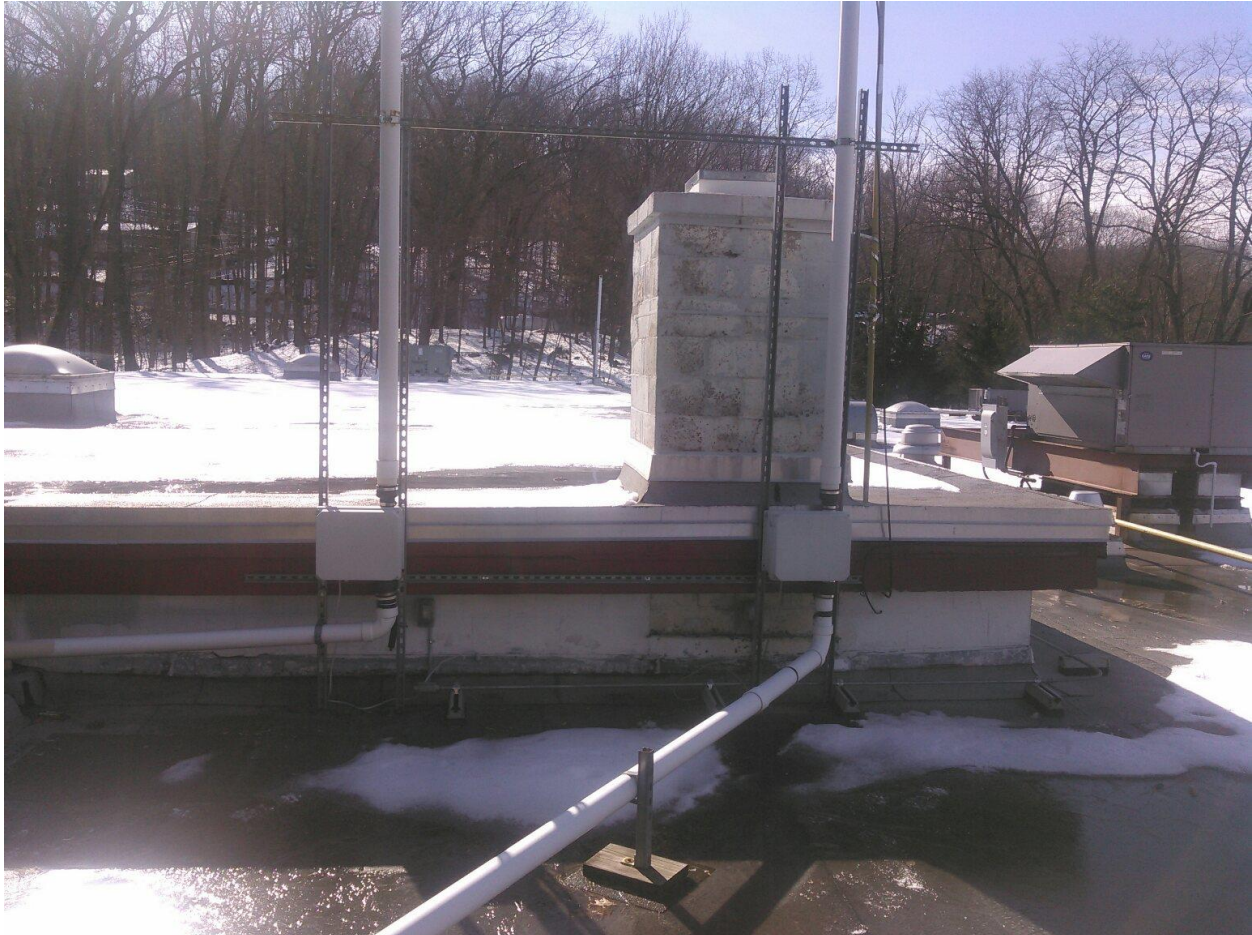
**Seen here are the northern and central fans.**

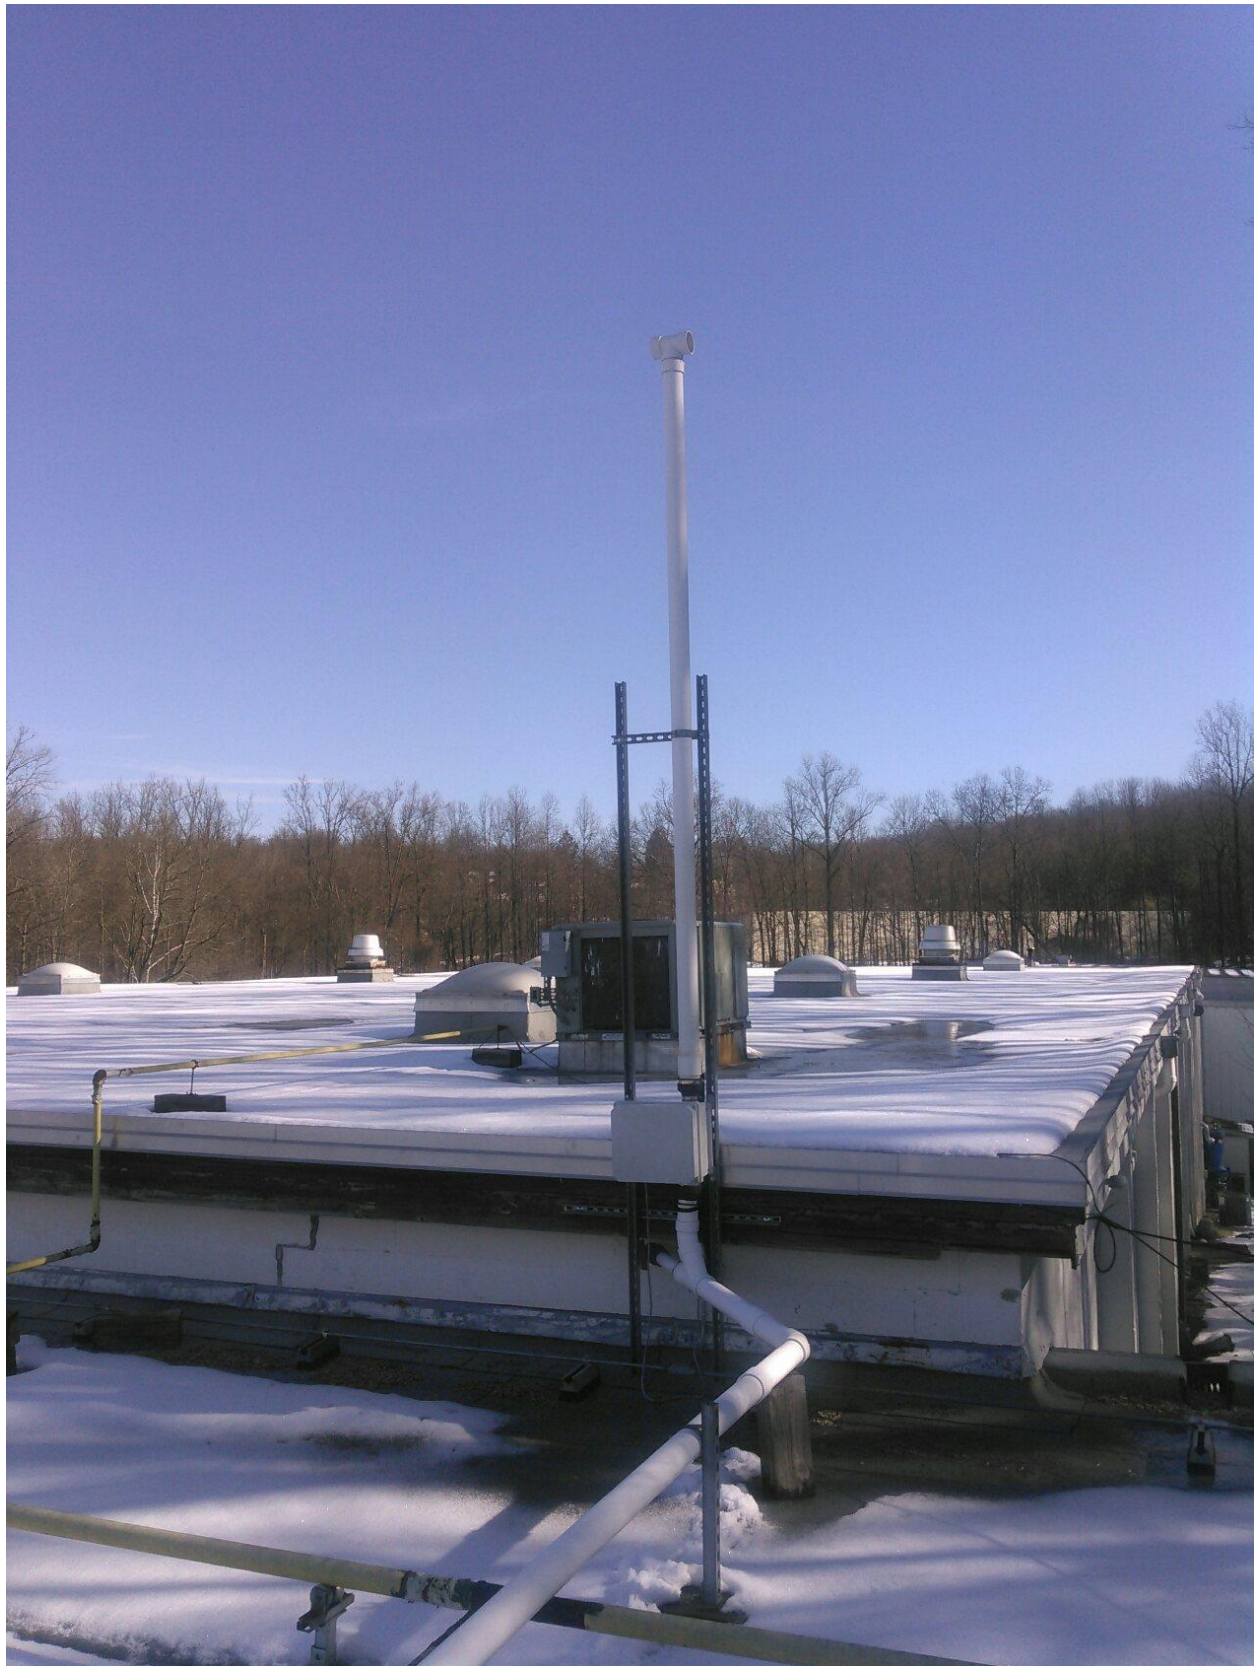
**Seen here is the southern fan.**

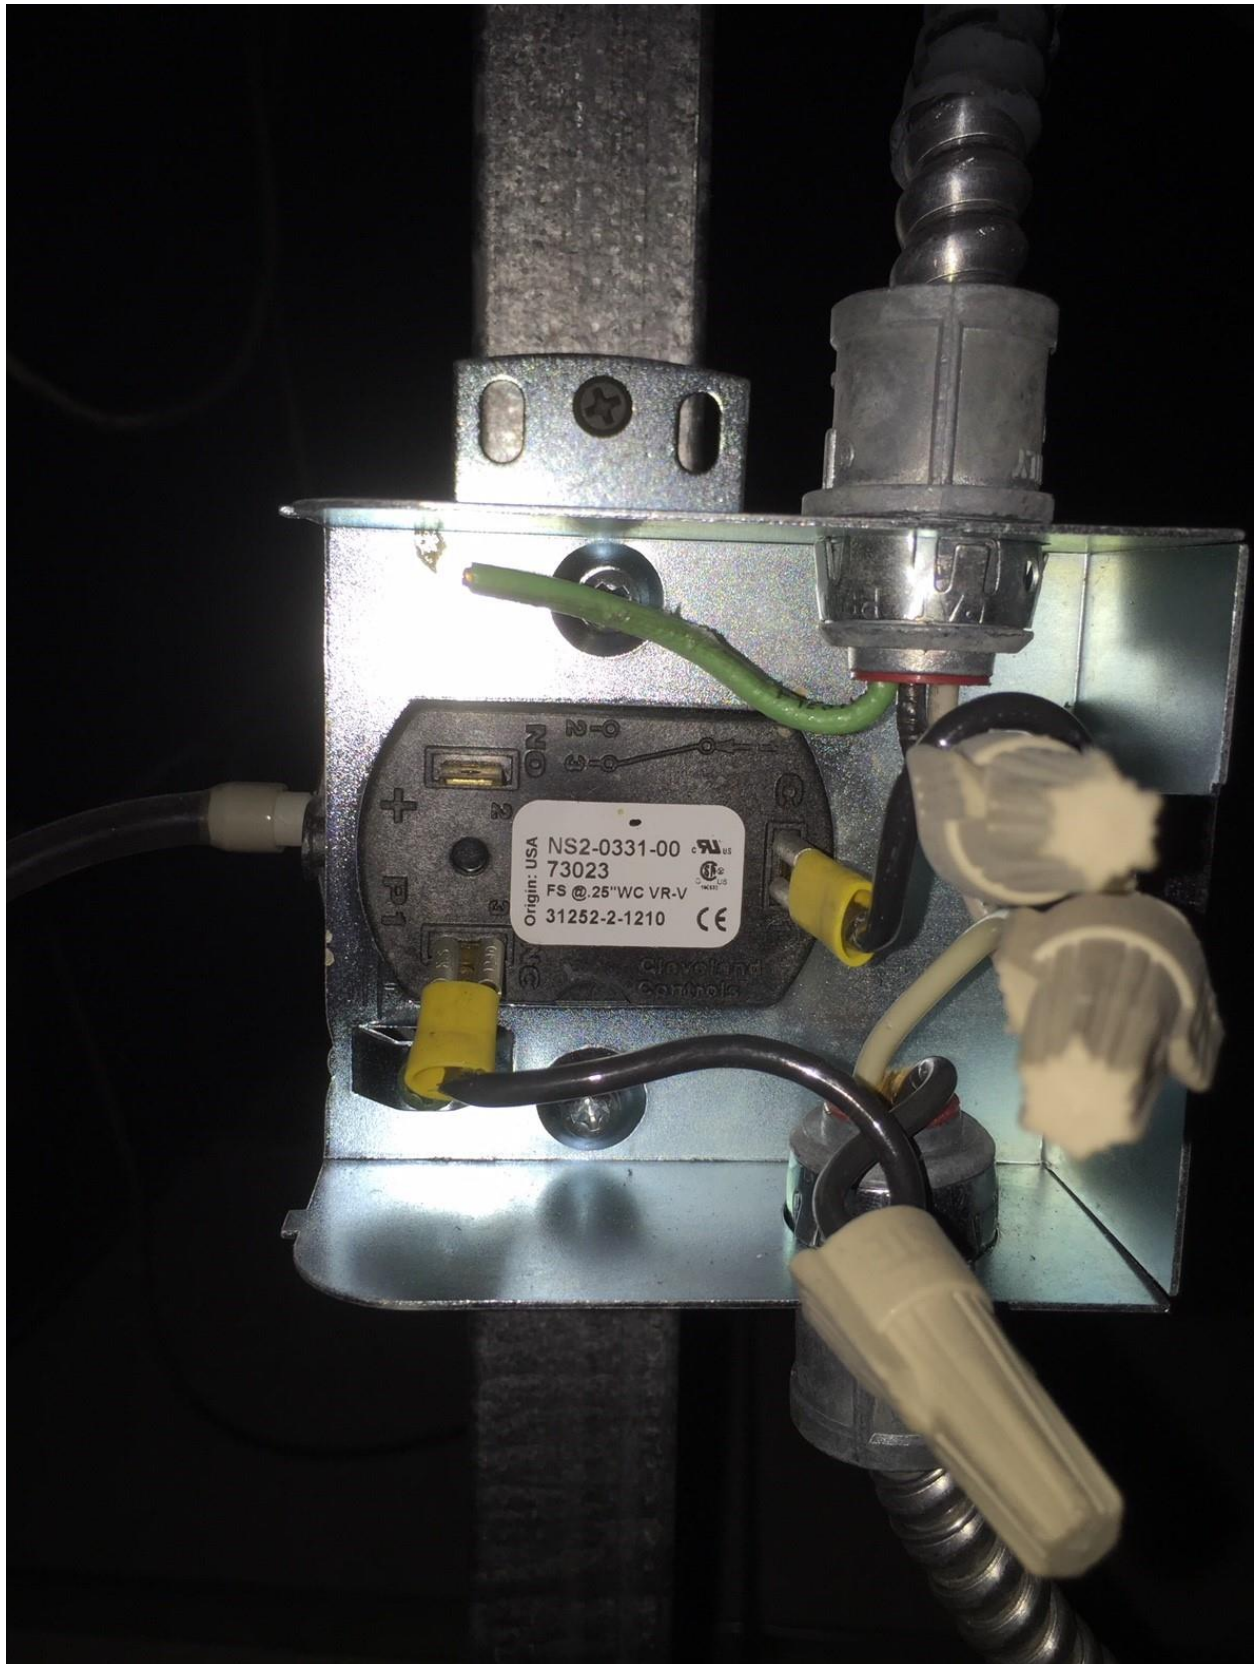
Findings from this inspection indicated that the air switch in the copy room was inoperable, and requires repair. The faulty switch disallows the "copy room" alarm light to illuminate in the case of a fan failure. Aztech recommends the repair of this switch as soon as possible. No other deficiencies were identified during this inspection and the system is otherwise running satisfactorily. Attached are relevant photos and the field inspection log for reference.

Seen here is the inoperable air switch.

Air switch in copy room is inoperable and must be replaced. All else is in order.
